**ATTAR TEST REPORT NUMBER: 14/8106.2**

**Total Pages: 2****WET PENDULUM SLIP RESISTANCE**

Job No: M14/8106

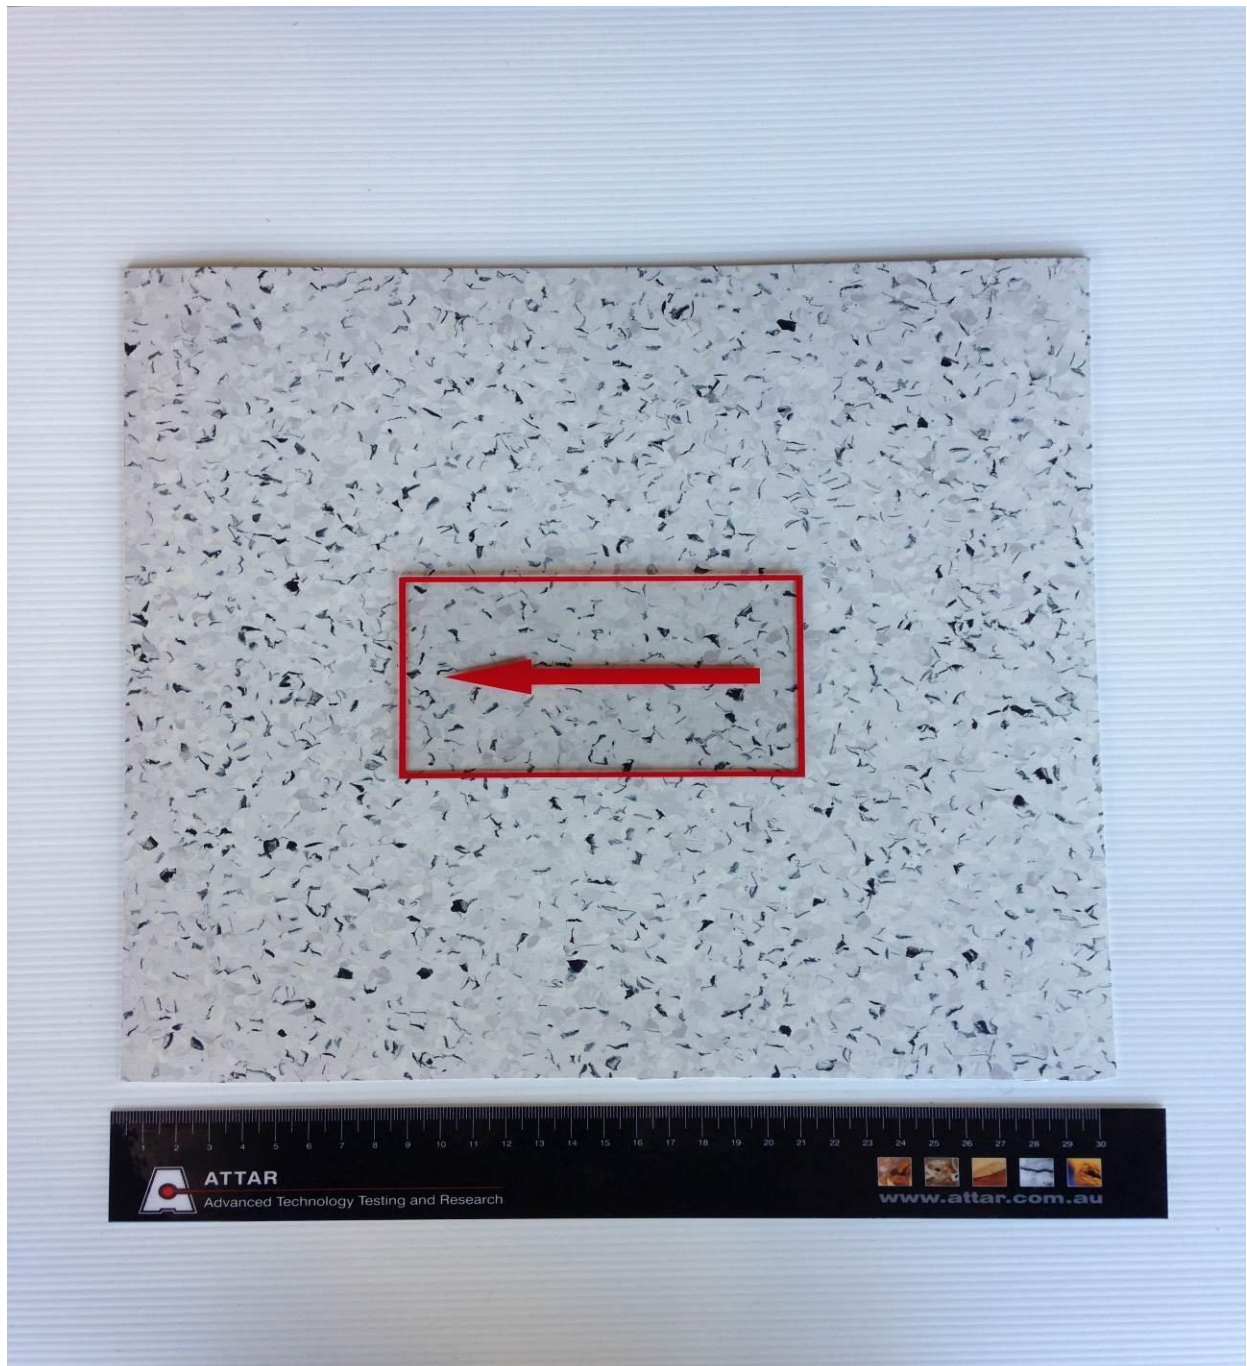
**Figure 1:** iQ Toro Sc – Highlighted area indicates area tested and direction of test.

<b>Slider Rubber:</b>	Slider 96 Batch No. #53 prepared on P400 & 3µm lapping film.					
<b>Classification Criteria:</b>	Refer to Classification Criteria, attached as Appendix 1.					
<b>British Pendulum Number</b>	<b>Specimen Number</b>					<b>SRV</b>
	<b>1</b>	<b>2</b>	<b>3</b>	<b>4</b>	<b>5</b>	
	53	54	53	55	55	54
<b>Classification:</b>	<b>P4</b>
